## FACADE & WALLS

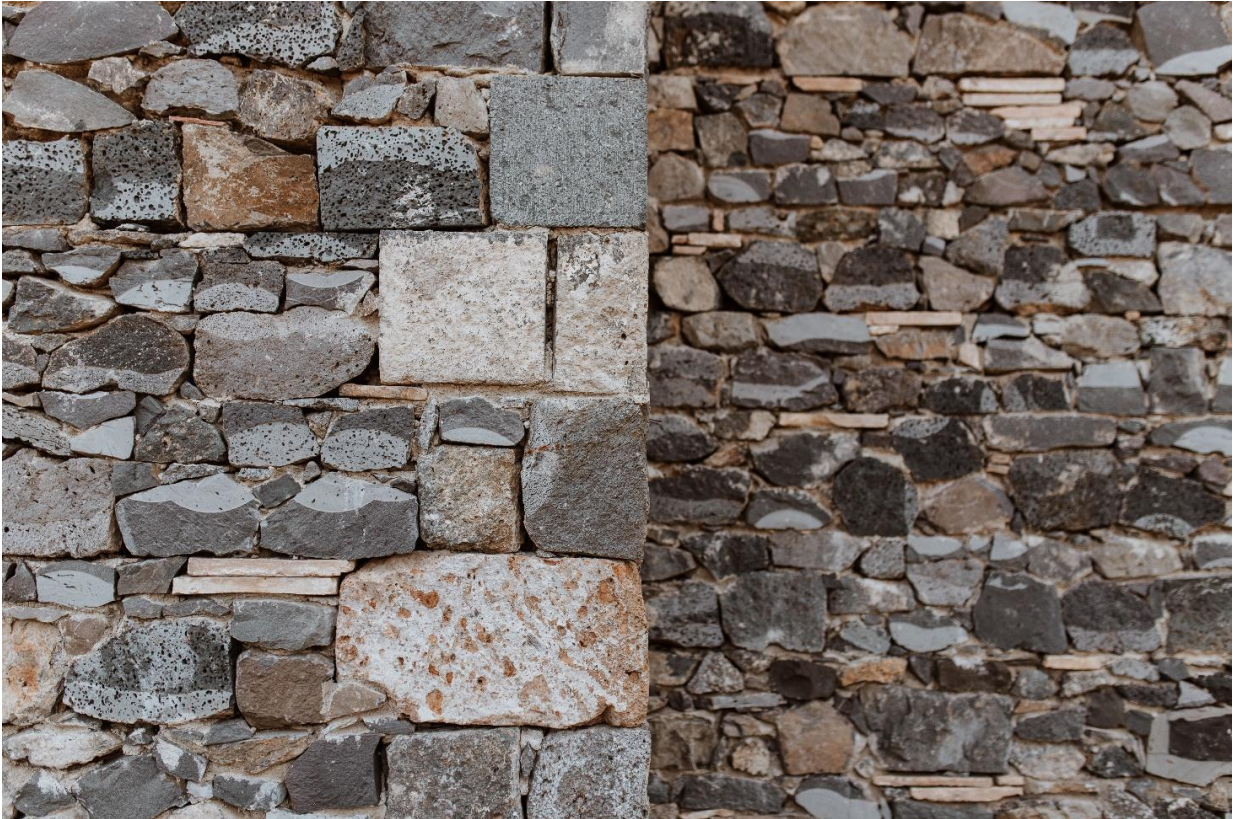
The outdoor area of the farmhouse, on the left side of the facade and of the entire part behind, was realized with the original stone of the farmhouse itself. We have disassembled and reassembled, selecting them one by one, all the existing original stones, using only the well-cleaned old stones, we have intentionally removed all the tufa stones, which were too porous, and we have only preferred the local grey stones that are the Basaltina and another particular grey stone, which used to be in the facade of the farmhouse and in the surrounding land, called “Occhiona” by the masons. “Occhiona” was in fact a beautiful compact stone but full of small holes that recall the inside of the bread or a gruyere. This is a type of stone that cannot be found on the market today.

In addition to these stones, during the rebuilding of the outer walls, we have installed the old handmade bricks that were in the ceilings and internal floors of the farmhouse, the terracotta tiles and other raw materials, and small stones that emerged during the renovation.

All these materials have been cut to size, split by hand and with technical means, and walled up with a technique called *wires* following a horizontal trend. Furthermore, some stones have been *ground*: the mark of the cuts of the angle grinder ([https://en.wikipedia.org/wiki/Angle\\_grinder](https://en.wikipedia.org/wiki/Angle_grinder)) on the stones is a representative element that gives a note of uniqueness and personalization in the way of mounting the Basaltina stone.

In conclusion, the old stones so modernized and the external bricks have been reassembled with a system that takes its cue from the drywall technique, eliminating and cleaning up most of the concrete between one stone and another.

In the wall with rough stone, the same are placed in such a way as to make the contours coincide as much as possible, correcting the profile possibly with smaller stones and filling the gaps between one and the other.

The other part of the facade - the main building and the right side of the house - was instead realized with a cement-based mixture of classic plaster, lime and small Pozzolana stones poured by hand with the *rough coat* technique. The rough coat is a layer of mortar, a conglomerate consisting of a mixture of binder (for example cement and/or lime), water and fine aggregates (including sand) and any additives, all in such proportions as to ensure workability of the wet mixture and mechanical resistance in the dry state, after setting and hardening, and having the purpose of making the base surface rougher and improving the adhesion of the plaster layer to be subsequently created. The rough coat is realized by throwing mortar with a fairly fluid consistency. The hand-made rough coat is also called *strolling*.

The final step of this part of the facade was then finished with Kerakoll siloxane paint, in dark grey color, passed with the spray technique. Above some windows the old chestnut wood beams were inserted as architraves, which were left in the light natural color. Ancient beams that belonged to the house, perfectly recovered, cut and treated. Furthermore, other windows have been made of Basaltina stone borders, bush-hammered and with a deliberately very porous texture.
